## Helical Tieback Anchors Stabilize and Support a Tilting Retaining Wall

Frisco, Texas

### Project Summary

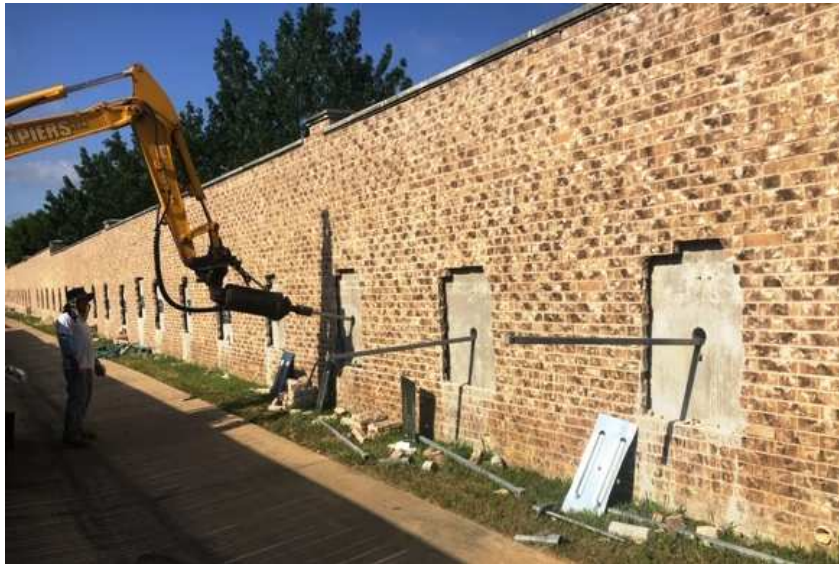
**ECP Torque Anchors™** are shown being installed using a hydraulic gear motor mounted to a mini-excavator.

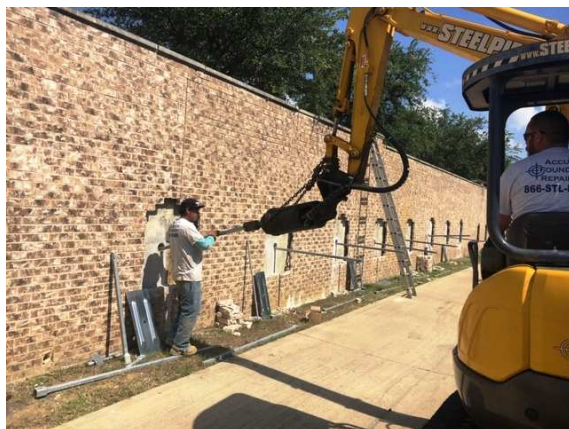
The top photo shows the area of masonry removed to allow anchor installation. The anchor shown in this photo is being load tested. A center-hole hydraulic ram is seen against the concrete wall.

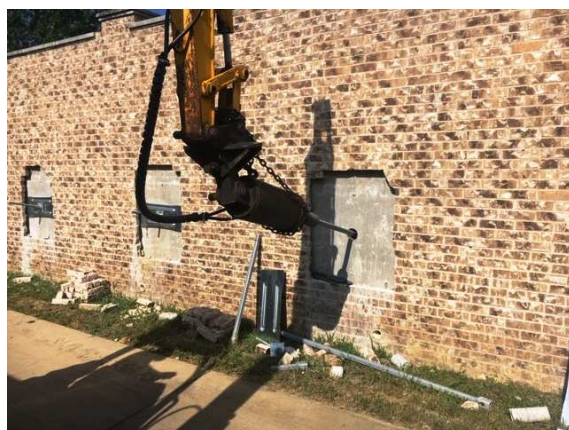
The lower photo shows the completed anchor installation, threaded transition shaft, plate washer and the wall plate.

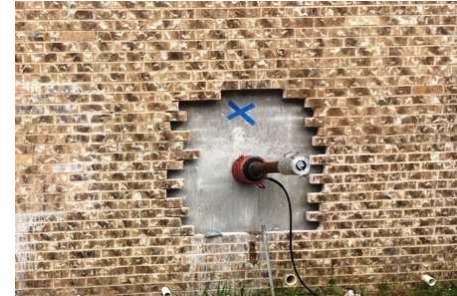
Top left photo shows **ECP Torque Anchors™** fully installed and tensioned.

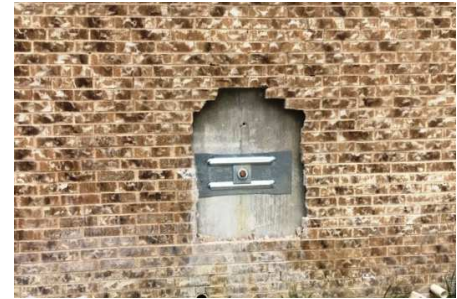
Photo, bottom left, is of the nearly completed project. The masonry has been replaced and will be stain matched to the original colors.
