## The First Law of Foundation Stability: Buildings Built on Land Fill will Settle.

Jackson County, Florida

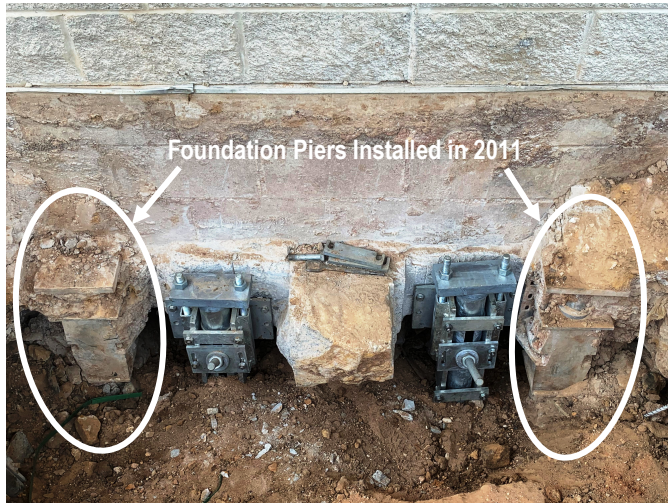
The existing building shows signs of foundation movements and instability. These appeared as separations between the wall and floor slab, stair-step fractures and vertical cracks in the masonry work and differential movement with cracks in the floor slab. The east wall of the building showed lateral movement toward the east along with wall rotation causing several roof joists to pull away from the west wall bearing plates.

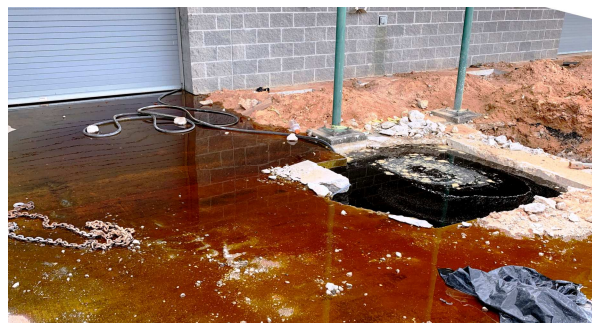
Directly above shows the filthy perched water flowing from below the structure.
