Foundation Settlement and Lateral Movement Rebuilt and Supported by ECP Steel Piers™ West Virginia

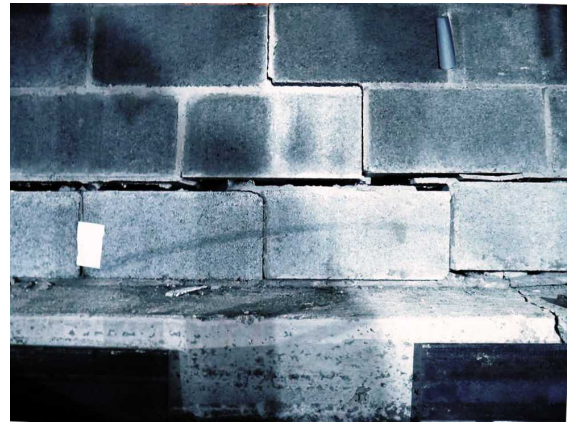
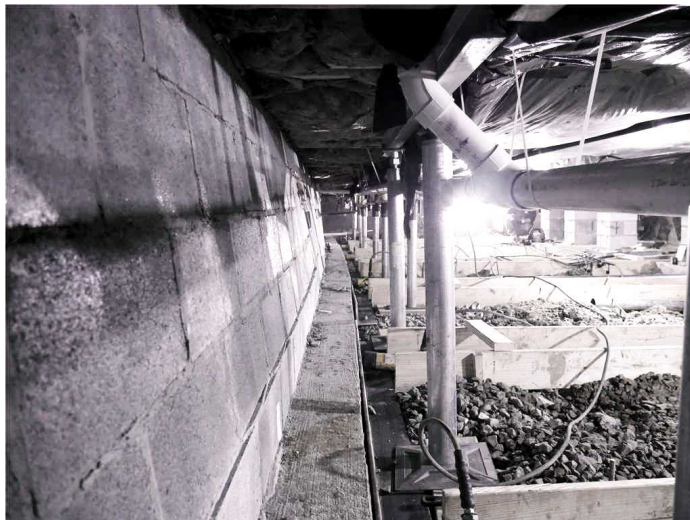
The homeowner noticed cracks in the drywall and serious door and window misalignments inside the house. This one year old home showed serious signs of foundation movement. Near the concrete spread footing on the rear exterior of the house there was serious masonry cracking and misalignments. One day when the homeowner was mowing, he noticed the entire back wall had become concaved, and the front wall had bulged forward toward the front porch.

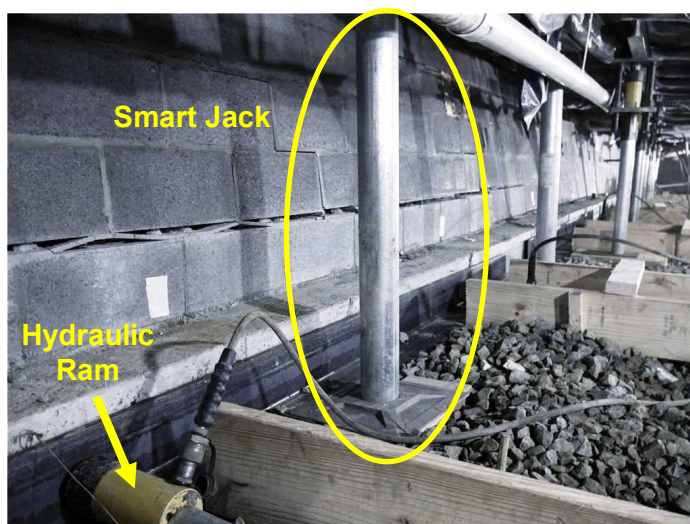
Inside the crawl space revealed substantial cracks spanning the length of the entire back wall and a spread footing with numerous fractures. The front wall had shown a substantial crack on the right side. It appeared that the porch which was built later and is not connected to the home's foundation. The porch had provided lateral support against movement and generally held the front wall in place. The rear wall had moved 2-1/2 inches inward at the footing. The front wall had rotated 1-1/2 inches outward toward the porch. These movements at the front and back walls and footings also caused slight distress to the left exterior wall. Along with observed wall movements, the concrete spread footings had settled from one to two inches within the crawl space. Extreme high humidity and groundwater was present in the crawl space.

Normally one would expect to raise the house off of the foundation and completely remove and replace the failed concrete footings at the perimeter. Usually a house moving company is hired to lift and support the structure while the spread footings are replaced. This is an extremely expensive and time consuming process. Foundation Systems of West Virginia found an innovative way to make repairs that were faster and economical.

The first order of business was to move the displaced and rotated concrete spread footings to the original location. The structural load was removed from the footing by using smart jacks to temporarily support the house. Once the concrete footings were no longer supporting the total weight of the house, hydraulic rams were evenly spaced in the crawl space. These hydraulic rams

applied horizontal force against the damaged concrete footings on the front and back walls. The slow and gentle horizontal hydraulic force caused the concrete footings to move back to their original locations thus straightening the walls.

The next step was to construct four concrete crosstie beams that interlocked with the perimeter footings to provide strength and stability. Once this was accomplished, the footing settlement had to be corrected and additional vertical support added to recover lost elevations.

Thirty **ECP Steel Piers™** with standard underpinning were installed on the perimeter. These steel piers were driven to a verified load bearing stratum deep below the unstable soil below the existing concrete footings.
