CASESTUDY

**1800'S HOME REPAIRED
AND LIFTED WITH
HELICAL PIERS IN ORANGE**

HISTORICAL HOME BUILT PRIOR TO 1890 LIFTED & REPAIRED WITH HELICAL PIERS IN ORANGE, CA

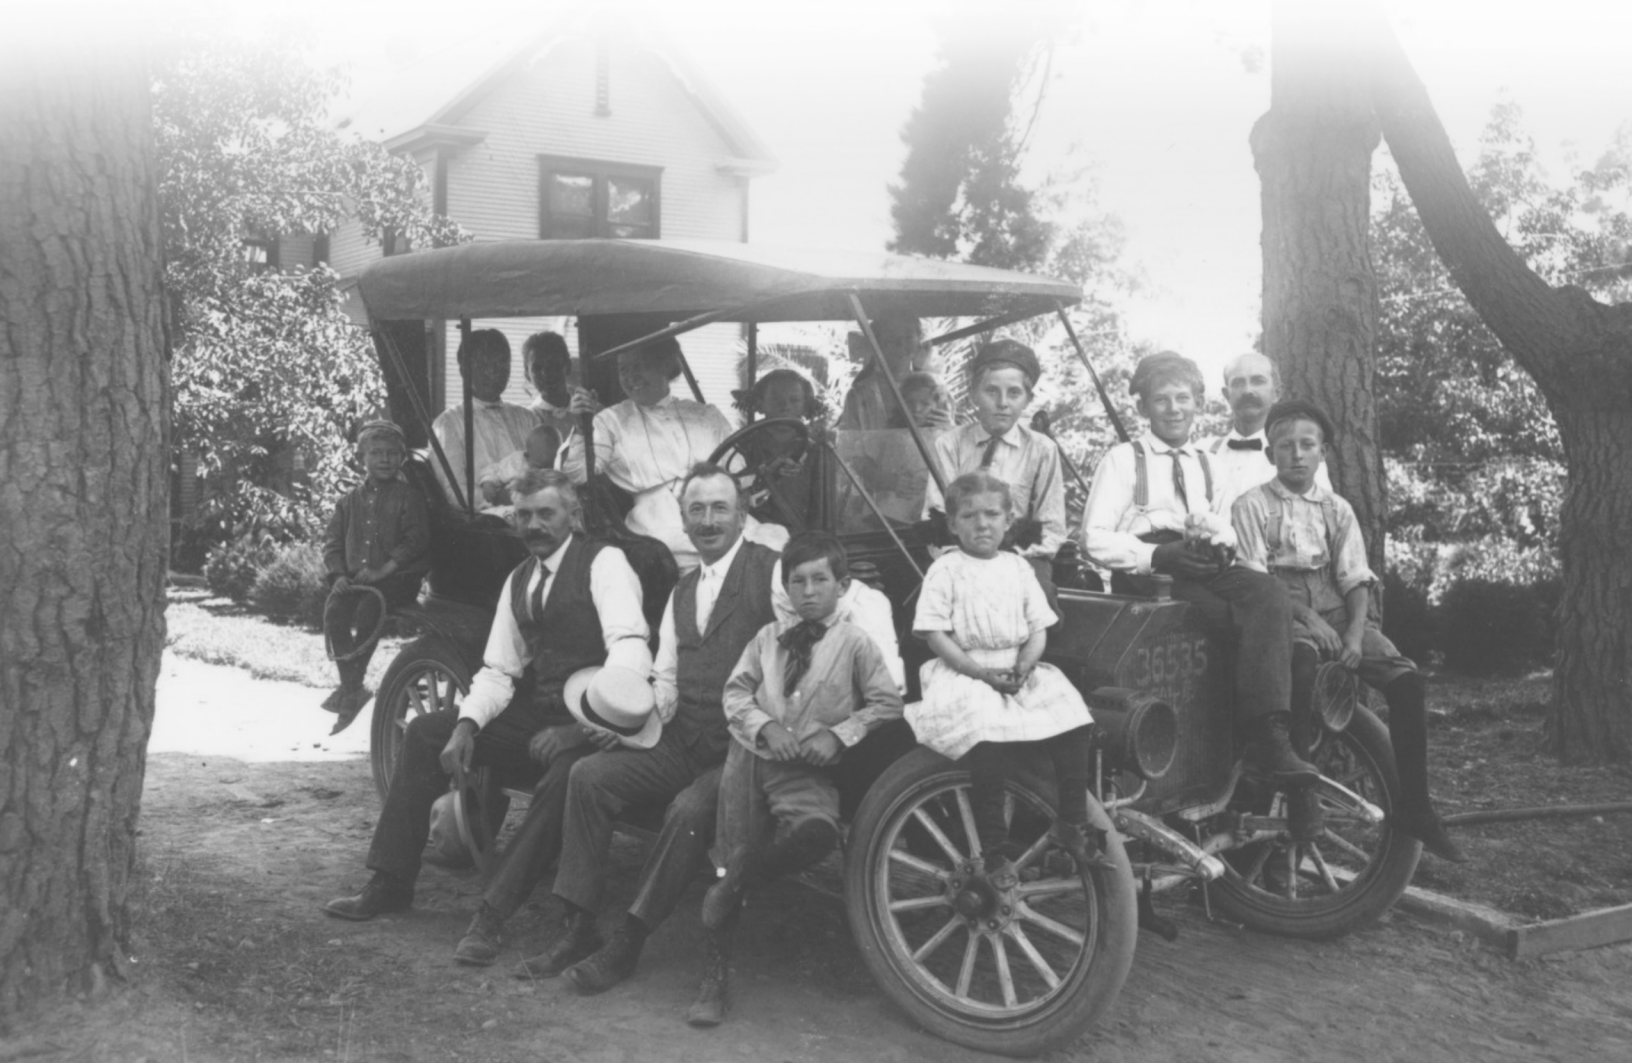
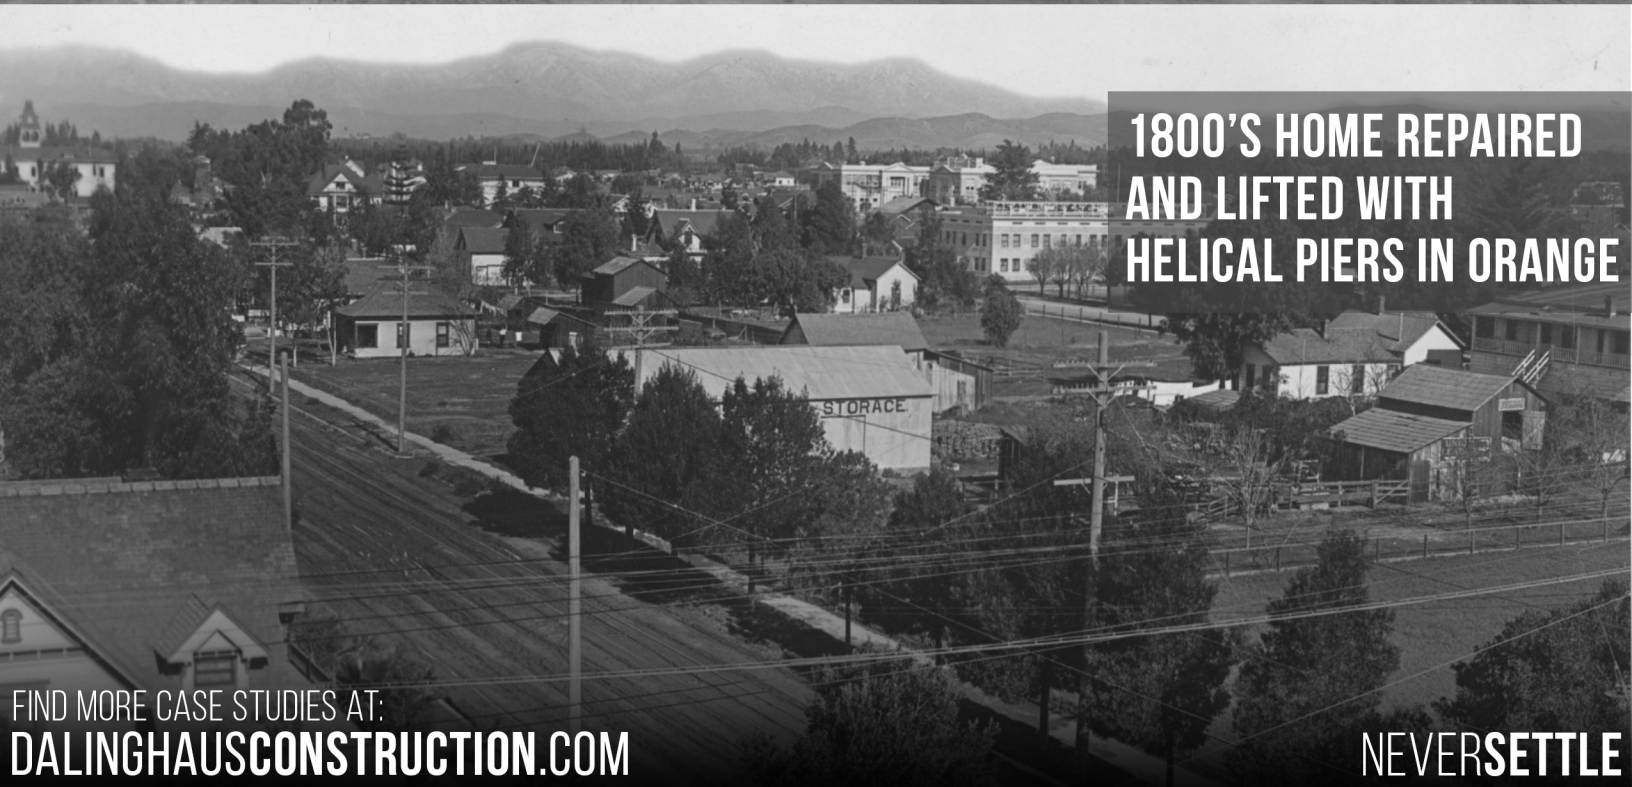
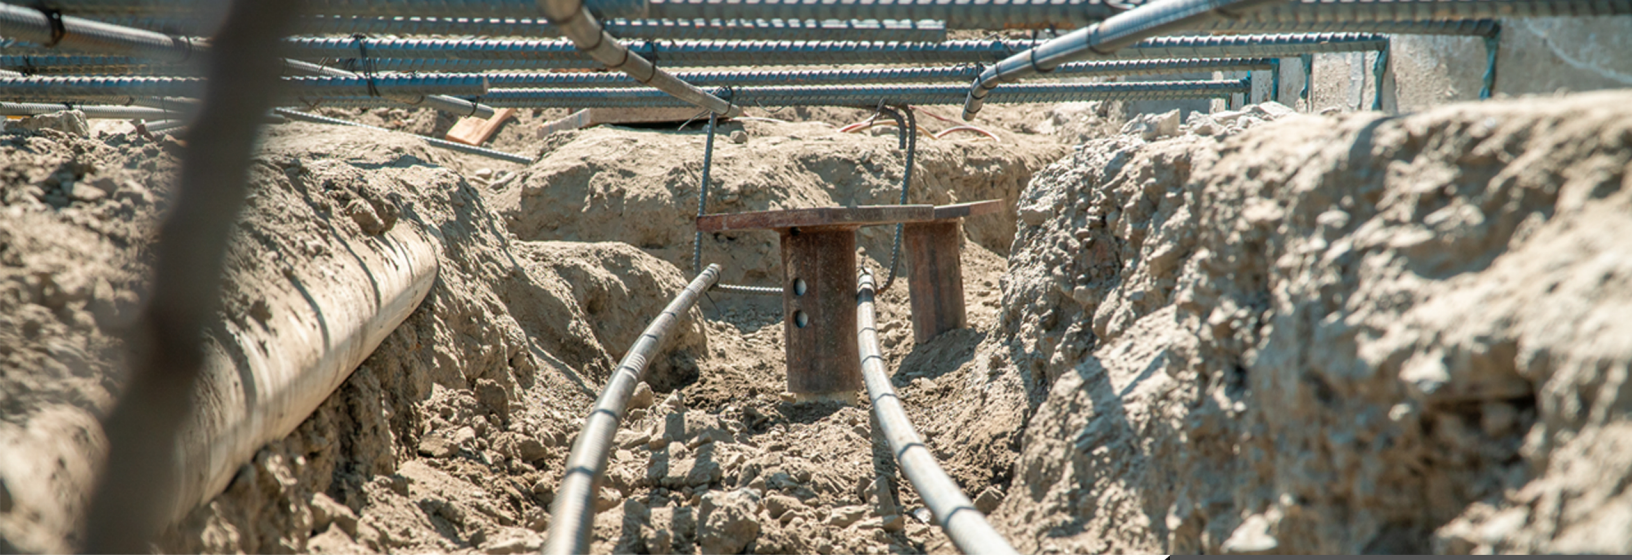
Dalinghaus Construction sent out Phil Laney, who performed the initial inspection on the home and measured over 1.7 inches of settling in the corner that had been previously repaired. While inspecting the home's crawlspace, Phil found multiple posts and pads that were in dire need of replacement with many of them no longer providing any support to the girder beams and sub-flooring.

With only 5 piers and a small amount of crawlspace work, Isaac's crew wanted to ensure they completed the project in just two days. They began by excavating the pier locations and found a rather shallow footing, which meant installing helical piers would be preferred over installing push piers. The team found that construction standards were much different back in the 1800's and this home was extremely light.

Once the excavations were complete, the crew was able to begin installing ECP's helical piers to predetermined PSI values of at least 1800psi. Once the piers were installed it was time for the brackets. The brackets allowed the crew to transfer the load of the home away from the incompetent clay soils on the surface and to competent soils 12'-14' deep.

While lifting the home to maximum practical recovery, Isaac's crew was able to recover 1.5 inches of settlement, and ensure the home would no longer face issues related to the incompetent soils it was built on. After lifting the home, the team headed into the crawlspace to replace the posts and pads, and strap all of the posts and pads to their respective girder beams.
