## Helical Tieback Anchors Stabilize and Support a Tilting Retaining Wall

Frisco, Texas

### Project Summary

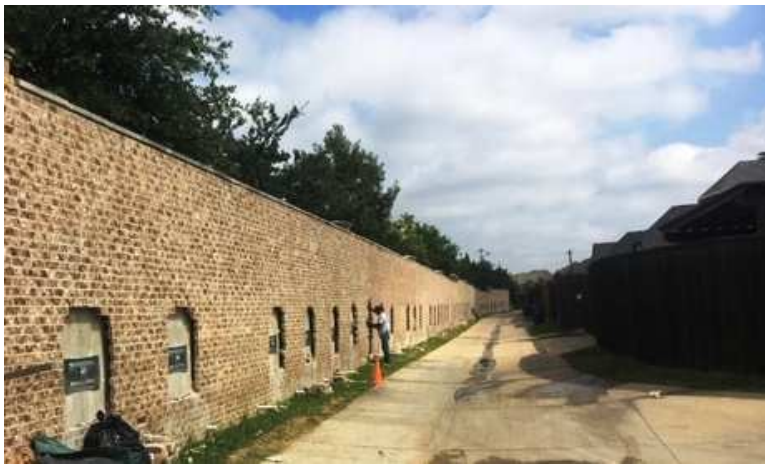
The lower photo shows the completed anchor installation, threaded transition shaft, plate washer and the wall plate.

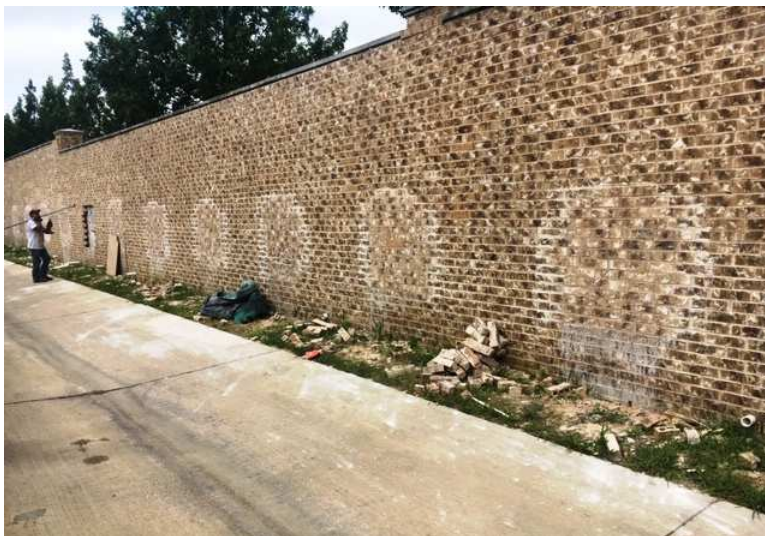
Photo, bottom left, is of the nearly completed project. The masonry has been replaced and will be stain matched to the original colors.
