## The First Law of Foundation Stability: Buildings Built on Land Fill will Settle.

Jackson County, Florida

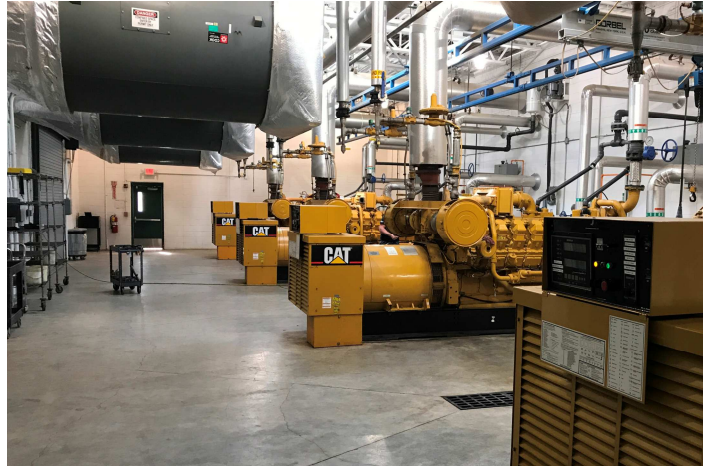
This Renewable Energy Facility Building was built in 2004 on land fill. The 20,000 square foot single story building was constructed with slab on grade foundation, concrete block walls and steel truss roof supports. The construction documents showed that the building is supported on a continuous grade beam that is 30 inches wide and situated 28 inches below the finished floor slab elevation. Concrete pads are present under multiple large 16 cylinder Caterpillar generators and other pieces of equipment, and equipment supports.

Google Earth® historical aerial imagery showed the building straddles the west edge of a closed landfill cell. The original building plans have a detail for the over excavation of the unsuitable land fill materials. Evidence shows that this specification was skipped by the original contractor.

The existing building shows signs of foundation movements and instability. These appeared as separations between the wall and floor slab, stair-step fractures and vertical cracks in the masonry work and differential movement with cracks in the floor slab. The east wall of the building showed lateral movement toward the east along with wall rotation causing several roof joists to pull away from the west wall bearing plates.
