Foundation Settlement and Lateral Movement Rebuilt and Supported by ECP Steel Piers™ West Virginia

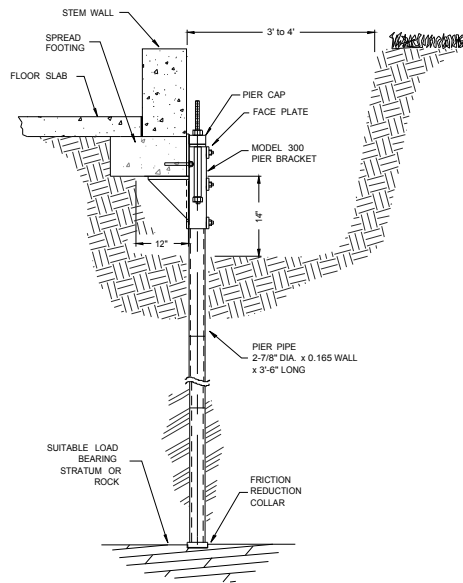
The photo and sketch above show typical installation and components of the ECP PPB-300 Steel Pier™

Thirty **ECP Steel Piers™** with standard underpinning were installed on the perimeter. These steel piers were driven to a verified load bearing stratum deep below the unstable soil below the existing concrete footings.
